# Beach lowering in front of coastal structures

Appendices 1-3

R&D Project Record FD1916/PR

This also constitutes HR Wallingford Report SR 633

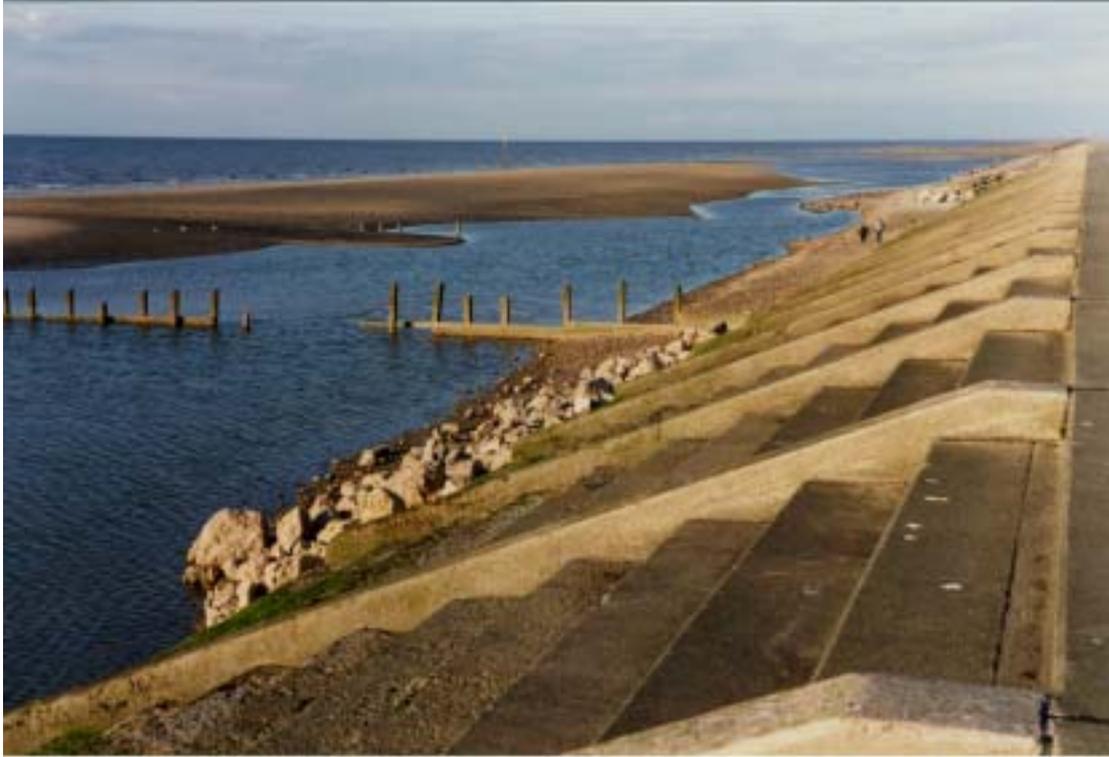
The photograph below, taken in early 1990, shows the tidal runnel very close to the wall. Note that the runnel extends a considerable distance alongshore, cutting across several timber groynes. All that remains at the toe of the wall is a narrow strip of pebbles. Some emergency works in the form of a fillet of rock armour-stone can be seen at the toe of the wall. The growth of algae on the concrete steps indicates frequent wave overtopping.

### **Toe scour in front of stepped concrete seawall, Prestatyn**

This frontage has required regular maintenance. In the 1980's, field investigations were carried out into the problems of wave and tidal induced scour and the strength of tidal currents over the foreshore. Rock groynes were constructed to reduce inshore tidal currents. This improved beach levels over the foreshore but the wall toe remained vulnerable to wave attack. Following substantial damage in 1990/1 a major scheme was implemented, including massive sand recharge coupled with the construction/ upgrading of the rock groynes. In addition, the vertical face of the seawall below the concrete stepped face was replaced by an asphaltic sloping apron.

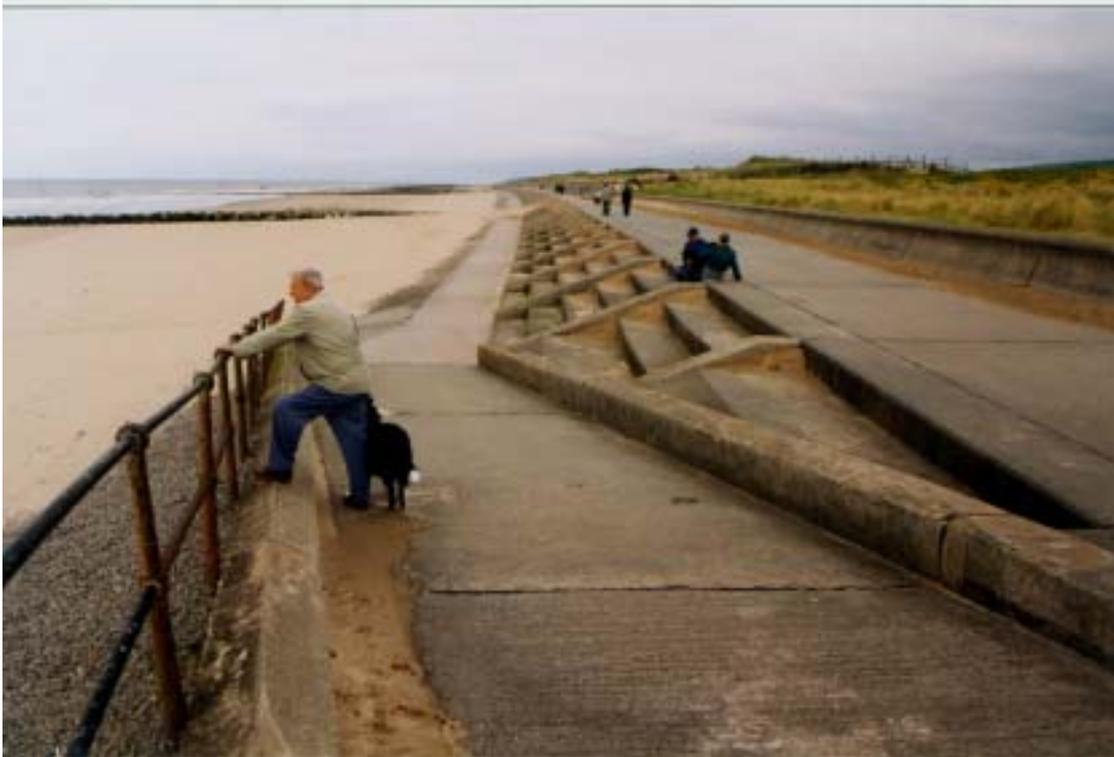
The increased height and width of the upper foreshore has resulted in the disappearance of the ridge and runnel features from in front of the seawall. The high foreshore levels have also removed the problems of wave overtopping. The photograph below shows the swash limit along the line of the new sloping revetment. There is some sand build up above the revetment and on the seawall steps. The amenity value of the promenade, at the crest of the wall, has also been greatly improved.

**Sloping asphalt apron and rock groynes in front of steeped concrete seawall, Prestatyn**

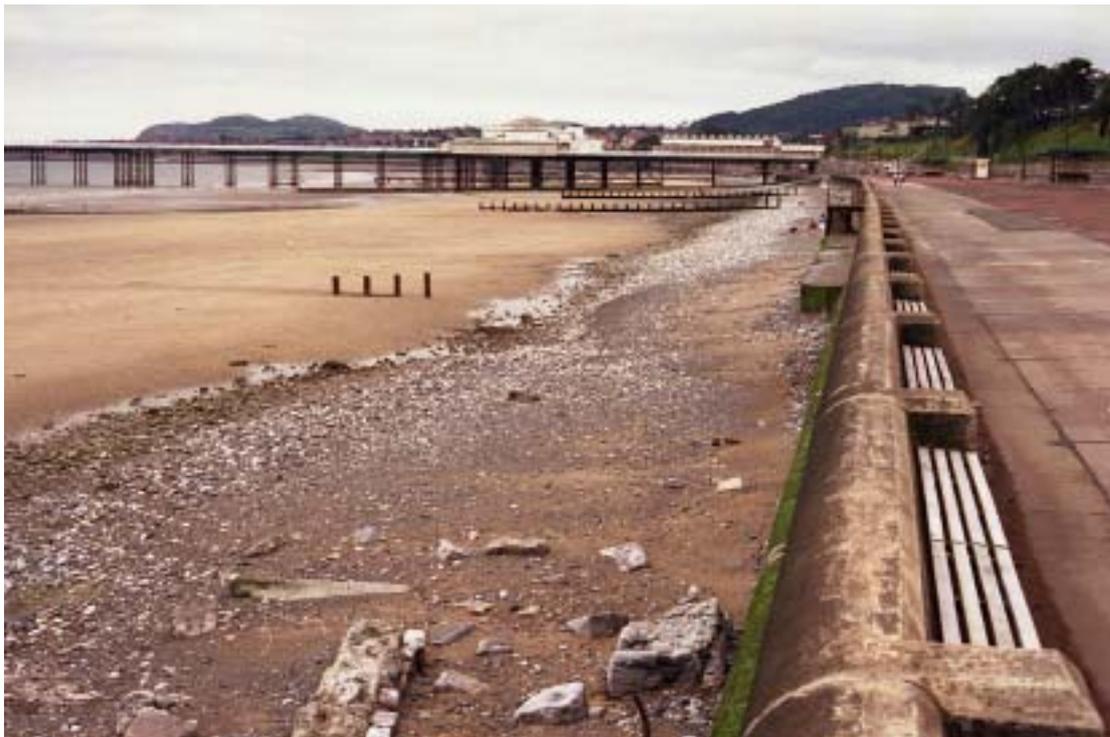
The construction of sea defences within Colwyn Bay dates back to nineteenth century. The masonry seawall has, over the years, suffered considerable damage, requiring extensive repairs and reconstruction. In the 1970's there was a groyned upper beach of shingle, with an almost continuous sand cover over the flatter, lower part of the beach. Subsequently the groyne system fell into disrepair, allowing beach levels at the wall toe to fall. Thus, by the 1980's the shingle beach had largely disappeared from the wall toe, causing foundation problems (see photograph below). In addition, the falling sand levels had exposed the underlying pebbles over much of the lower foreshore.

**Beach lowering in front of vertical seawall, Colwyn Bay**

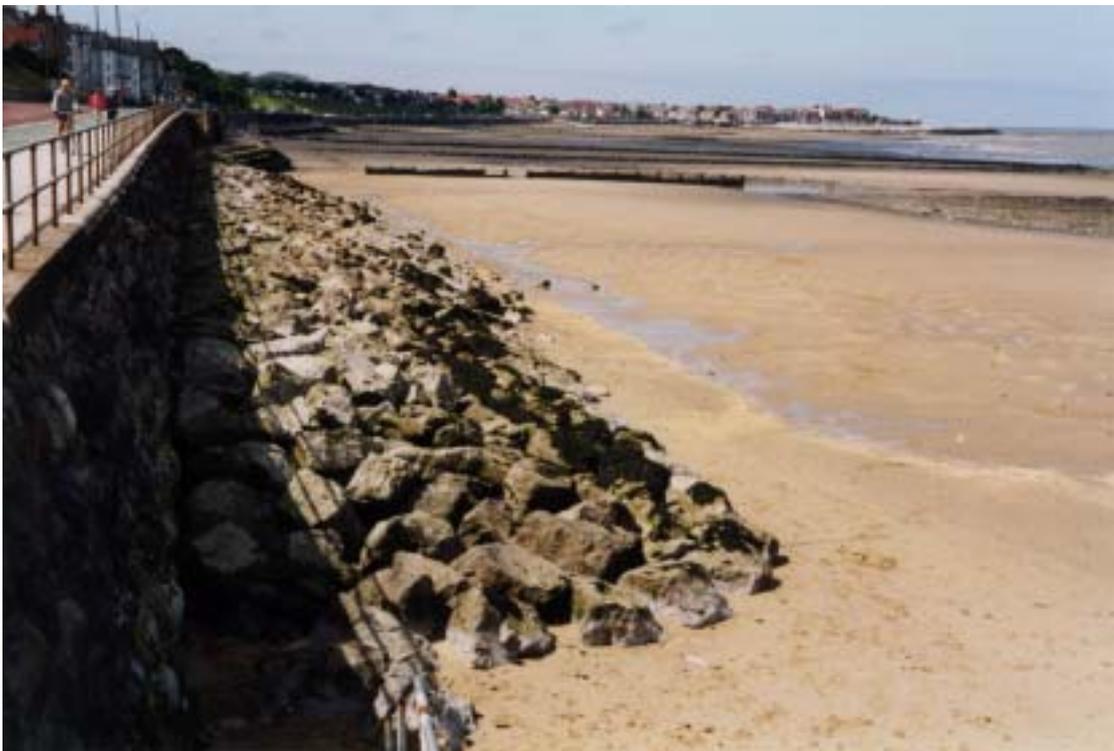
This scheme is a good example of how relatively modest defences can be used effectively to improve beach levels. The photograph below, taken in 2002, shows the sand build up at the foot of the seawall. The long rock groynes can (just) be seen in the background, while a redundant timber groyne can be seen in the middle distance.

**Rock berm in front of vertical seawall, Colwyn Bay**

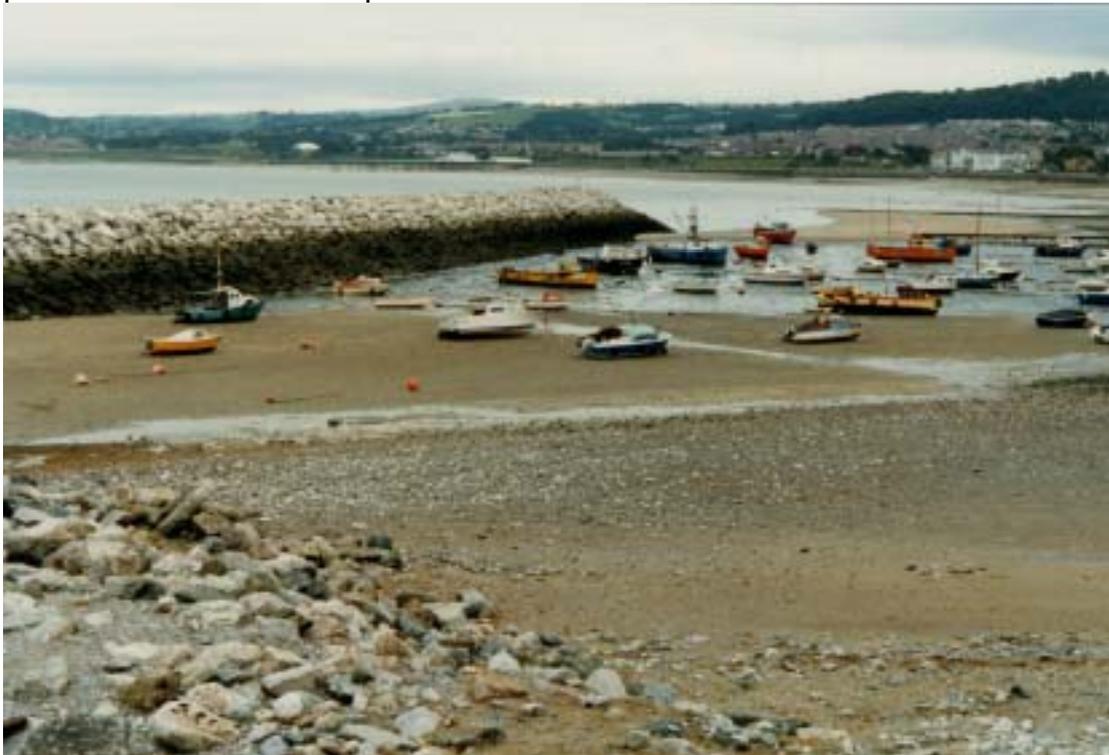
**View to the east showing usage by small boats**

The breakwater has eliminated the problems of wave overtopping that were becoming increasingly more serious to the south of Rhos Point. The sheltered conditions in the lee of the breakwater have allowed small boats to anchor there (see the first photograph below). This has been possible because the breakwater is sited some distance away from the wall, but not so far offshore that its sheltering effect would be significantly reduced. The low groyne has been overtopped by beach material and shingle and sand have tended to collect in the lee of the breakwater, further reducing any potential risk of wave overtopping (see the second photograph below).

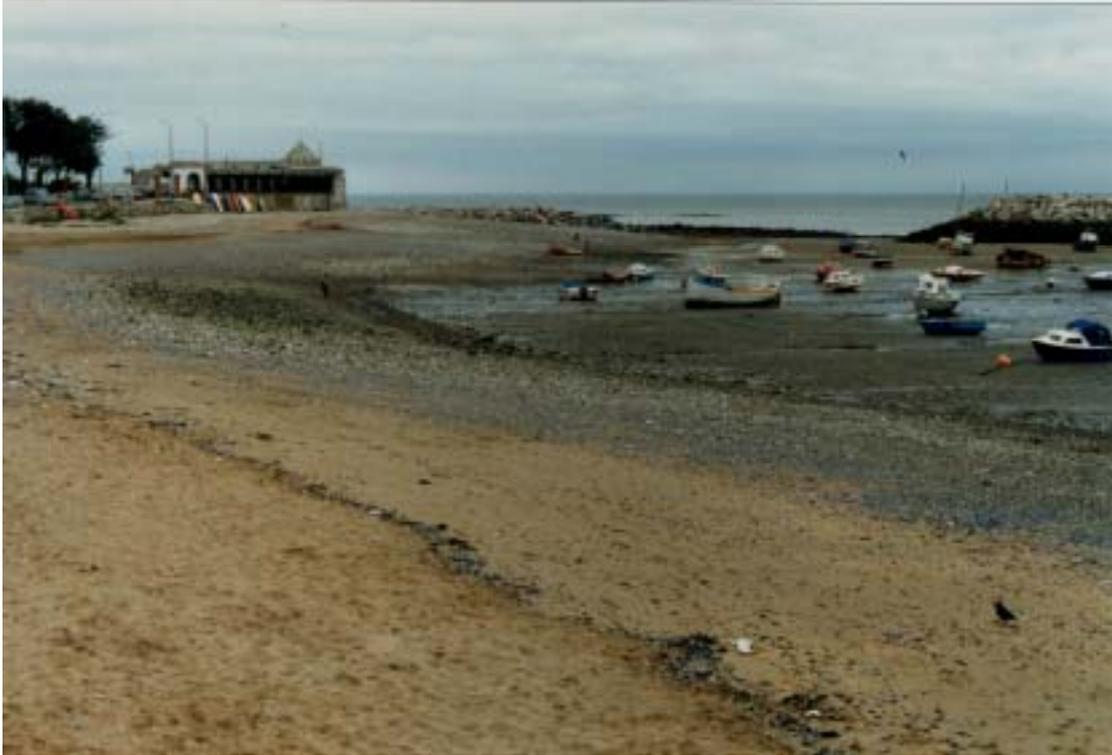
**View to the west showing beach recharge**

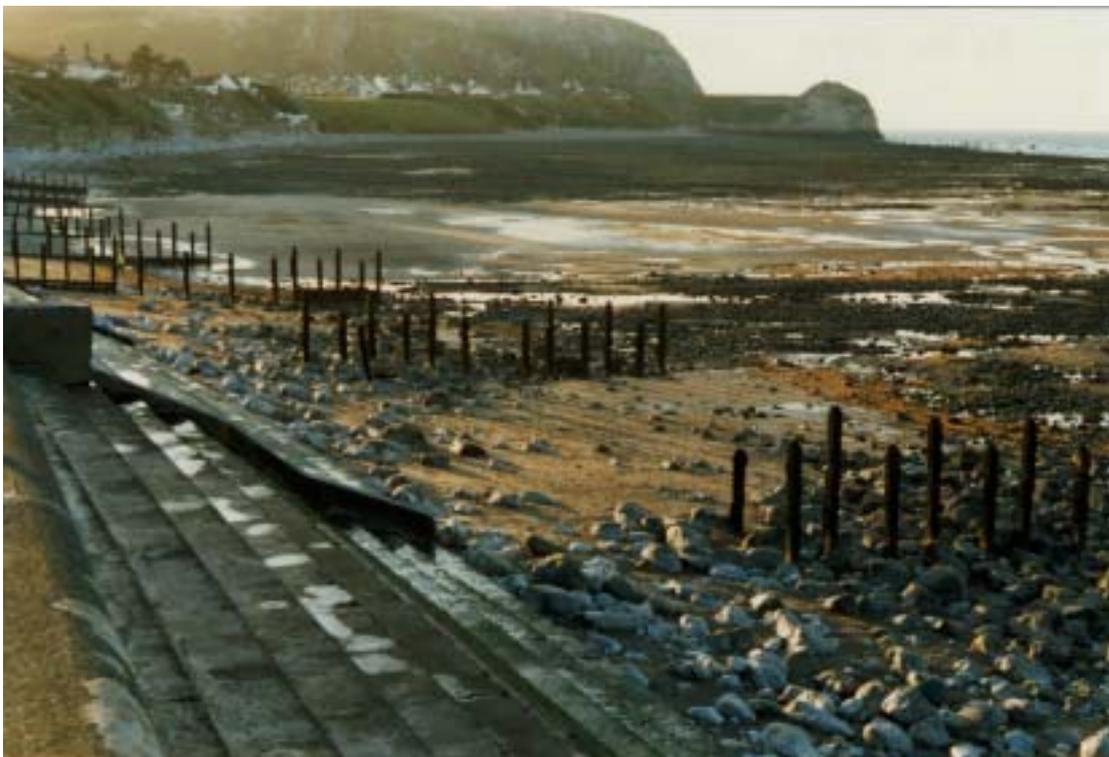
**Lowered beach exposing shore platform, Penrhyn Bay**

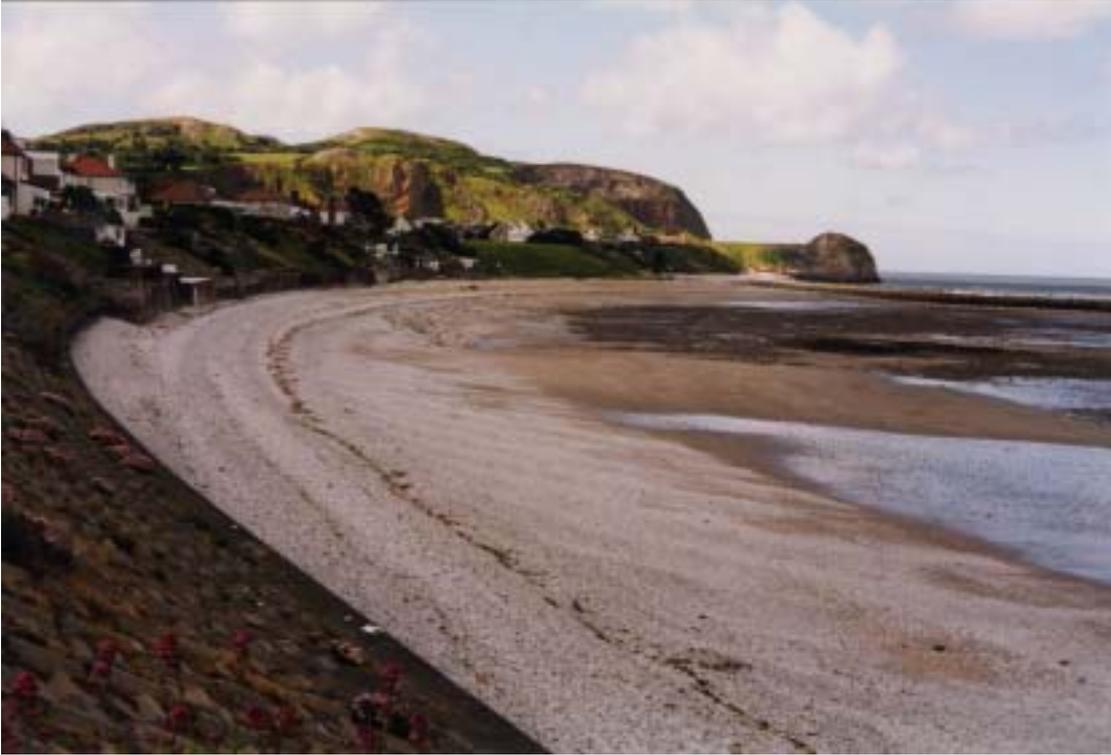
**View of beach recharge in western part of Penrhyn Bay**

This innovative scheme has been very successful. The combination of the artificial beach recharge and the fishtail groynes has effectively reduced the erosion of the upper beach and contained the beach sediments within Penrhyn Bay. The artificially formed beach has a sufficiently high crest to prevent waves reaching the seawall (see photograph below).

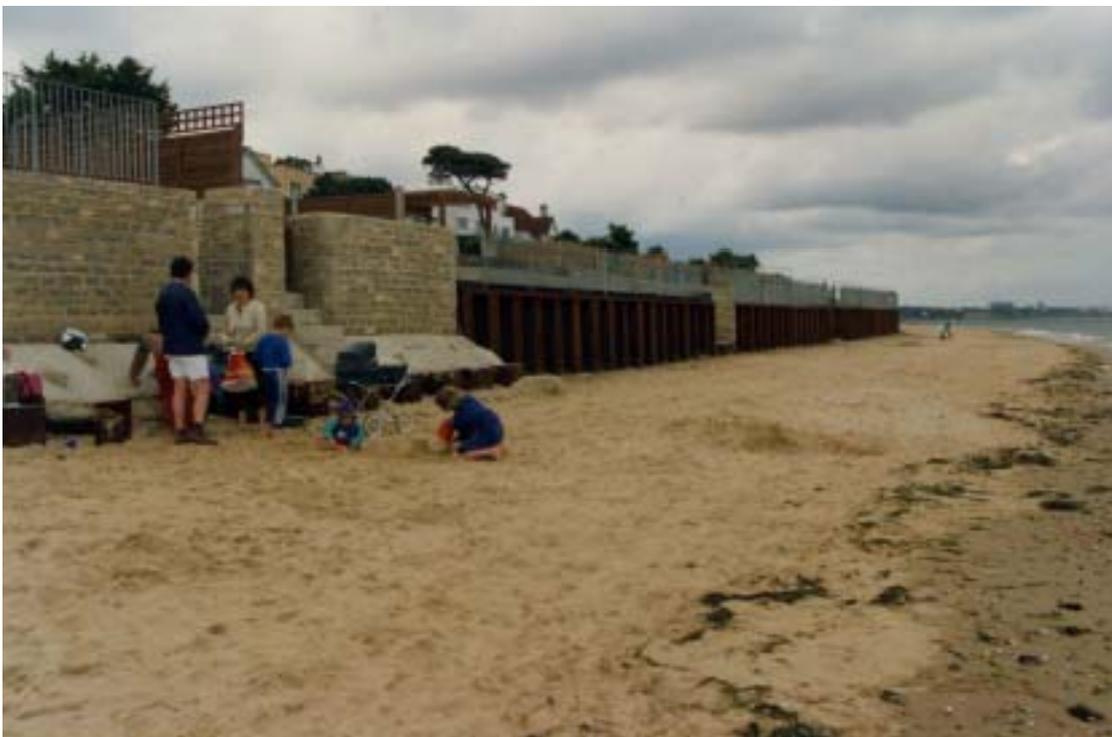
The sand beaches along the Sandbanks peninsula were originally protected by a system of crib type rock groynes. Historic charts show these maintained high beach levels over much of the frontage. However, these groynes fell into disrepair, being removed in 1991 for health and safety reasons. Beach lowering was noted subsequently, becoming most serious at the western end of the frontage, where a seawall surrounds the head of the peninsula. The offshore transport of sand, due to waves being reflected from the wall and its subsequent removal by the fast tidal currents, caused concerns that the wall would become undermined.

**Vertical wall and low beach near Haven Hotel, Sandbanks (c1998)**

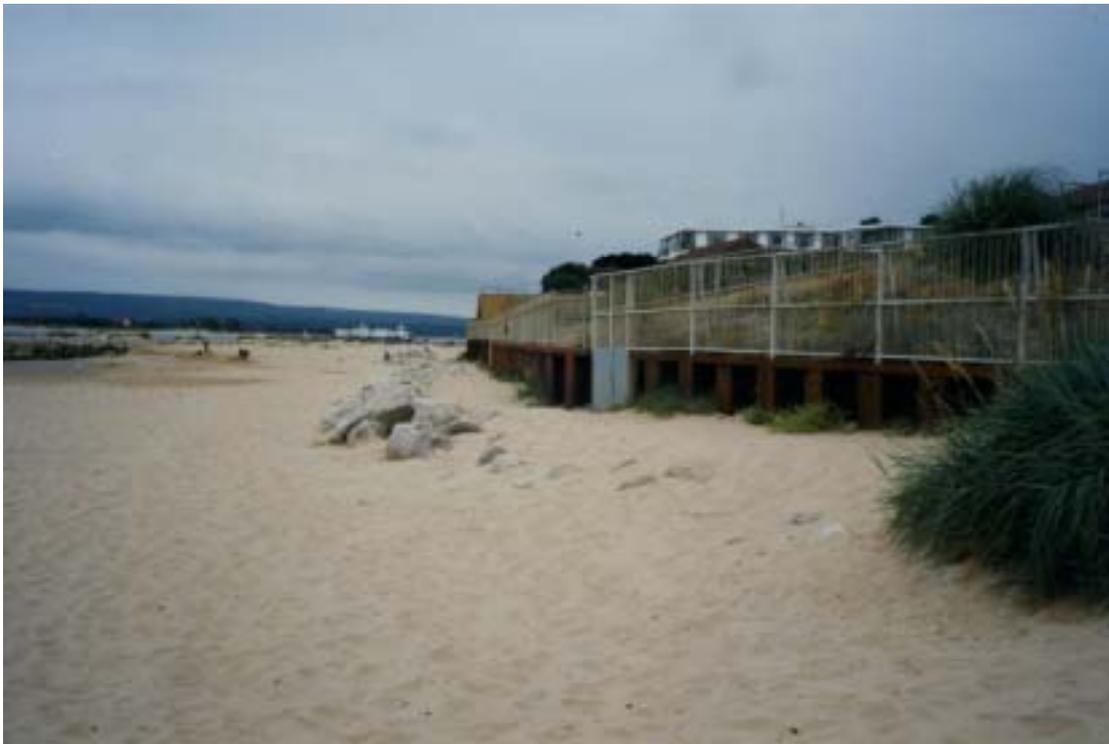
**Widened beach after installation of sill and rock groynes, Sandbanks (2002)**

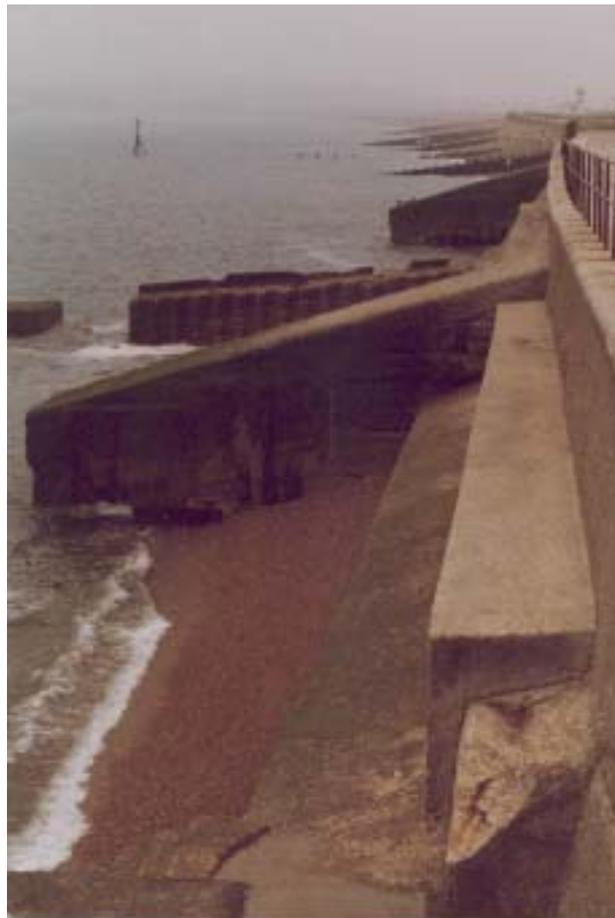
The subsequent development of the port of Newhaven has included the construction of training walls to prevent the littoral from blocking up the new entrance. Successive extensions of the western training wall were necessary as the beach to the west of the entrance accreted. This meant that the shingle beach at Seaford has received a dwindling supply of shingle. This has caused beach levels in front of the seawall to fall at an increasing rate during the last century. By 1980, the beach in the eastern half of the frontage had fallen to such an extent that it was providing very little support to the old mass concrete seawall. (This wall was originally a secondary defence behind a then substantial shingle ridge.) In places erosion had exposed the underlying chalk platform, allowing waves up to 6m high to reach the wall without breaking. In 1981, parts of the wall had become badly damaged and in 1985, undermining had caused local collapse of the promenade.

**Low beach levels and damaged concrete seawall, Seaford (c1982)**

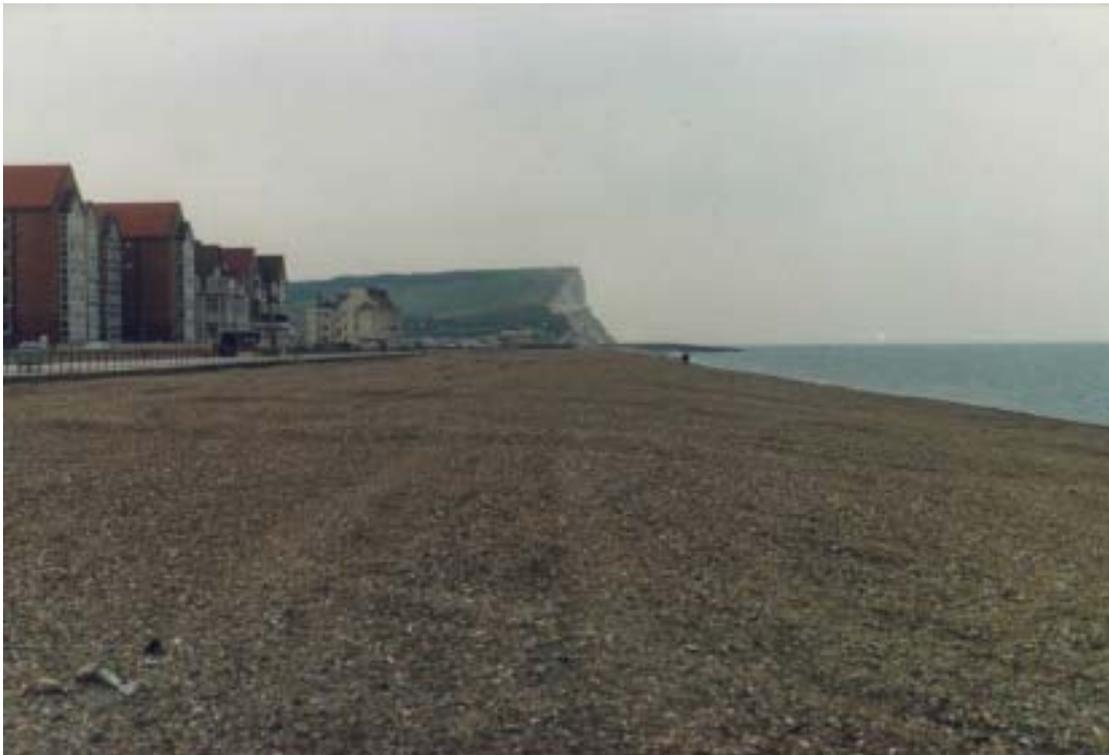
In 1987, the central and eastern end of Seaford was nourished with 1.5 million cubic metres of shingle won from offshore. The material was won by using a trailer-suction dredger, extracting the material from an existing licence area on the Owers Bank, south of Selsey Bill. The material was spread over a 2.5km frontage. The western frontage was left untouched, as the beach there was already wide.

Following the initial period of adjustment the beach actually increased in volume within the active beach profile (taken as above  $-4\text{m}$  AoD). This is because the wave reflectivity was significantly reduced, causing pebbles to migrate landward from the hard chalk seabed on which material was very mobile.

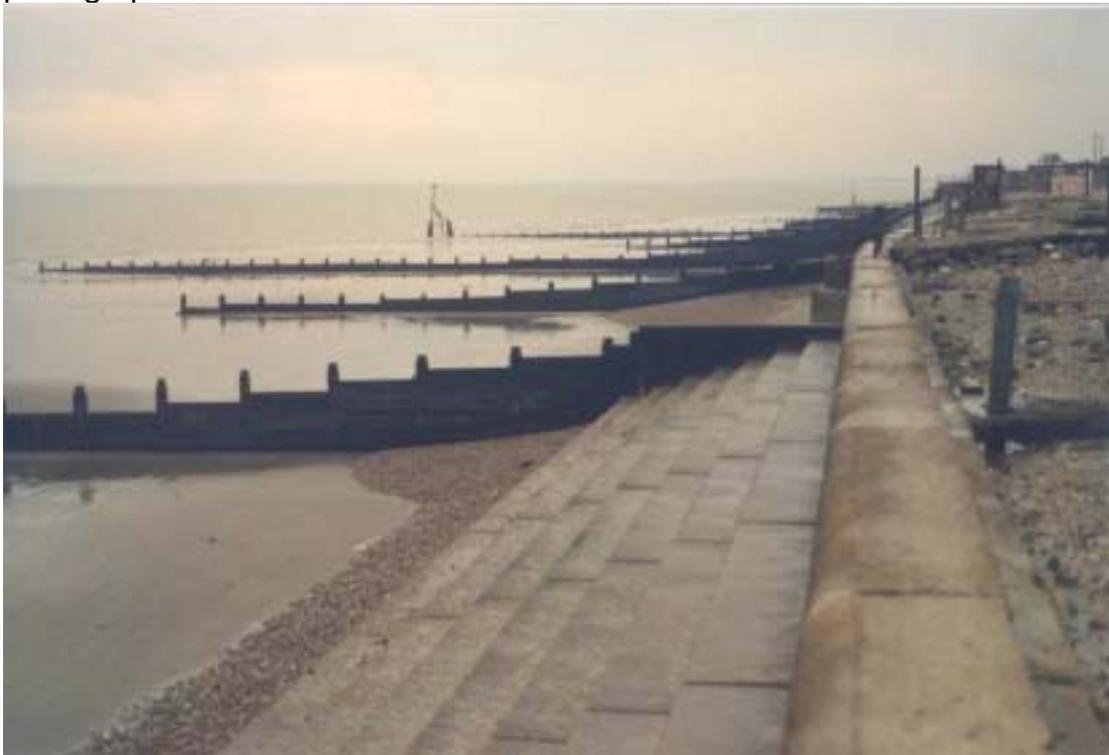
Sea defences were begun in the 1950's. With an onshore supply near the Bill the beaches did not deteriorate as rapidly as might have been expected, in view of the earlier very rapid rates of retreat. However, by the late 1980's the walls had deteriorated through continuous wave action and falling beach levels. The photograph below shows the situation in 1988.

**Low beach levels in front of stepped concrete wall, Selsey Bill (1988)**

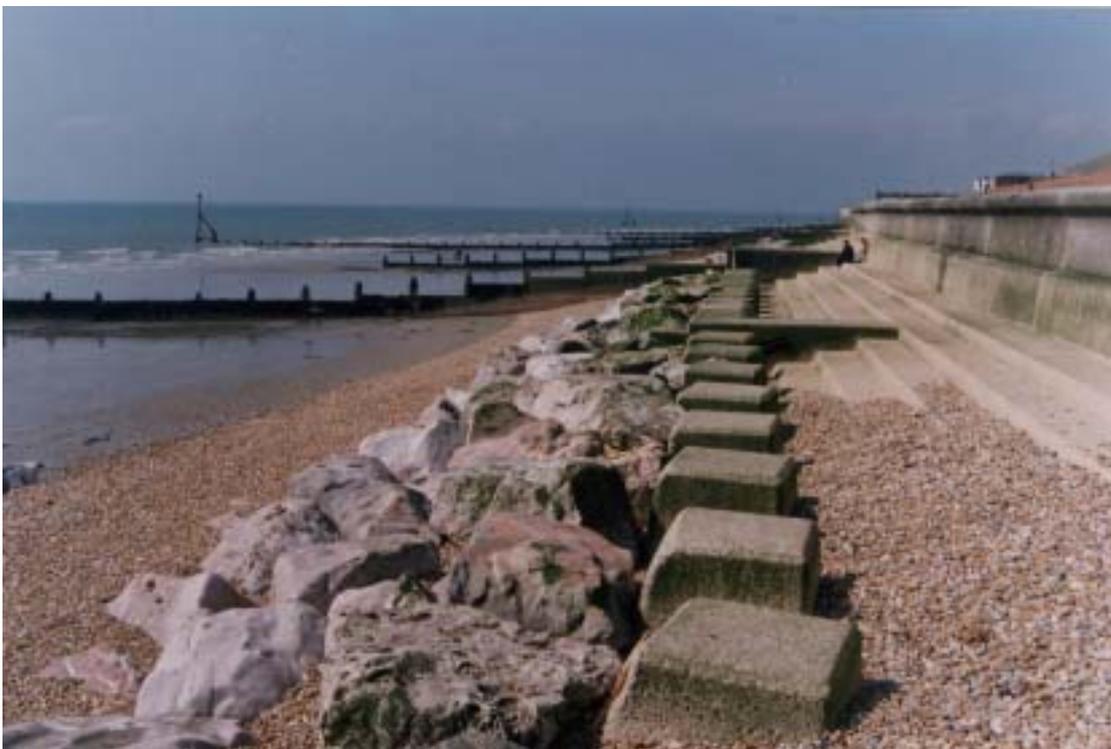
**Toe berm of rock and concrete armour units, Selsey Bill (1994)**

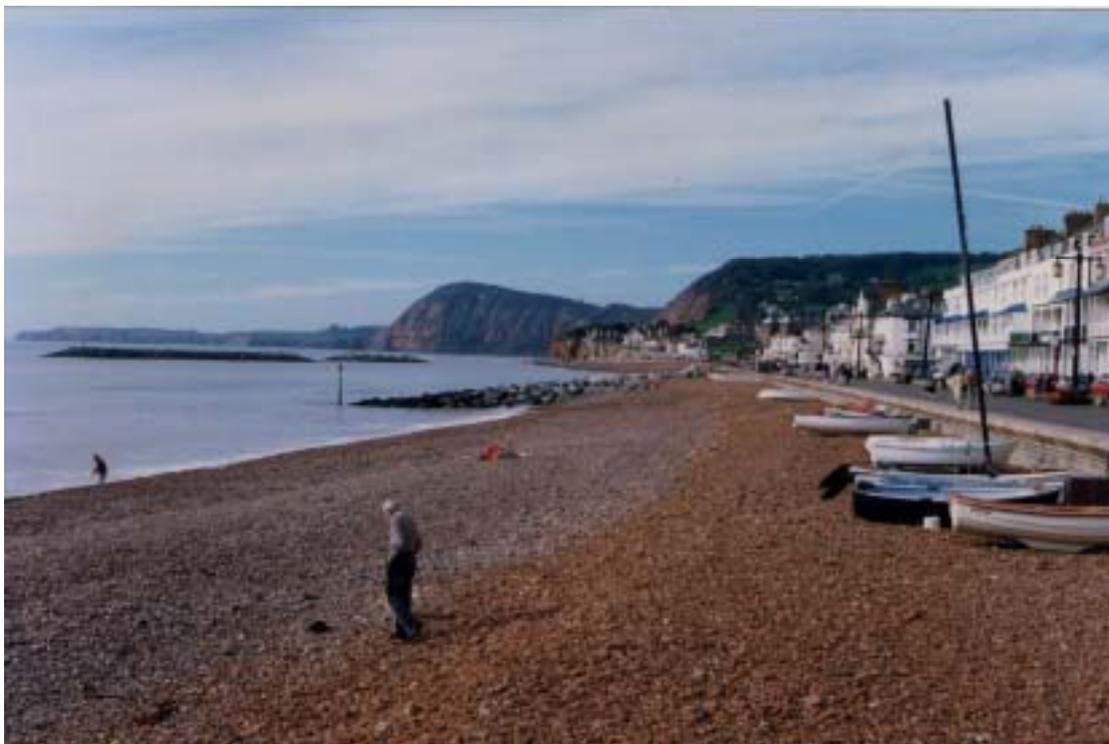
**Beach recharge, groyne and offshore breakwaters, Sidmouth**

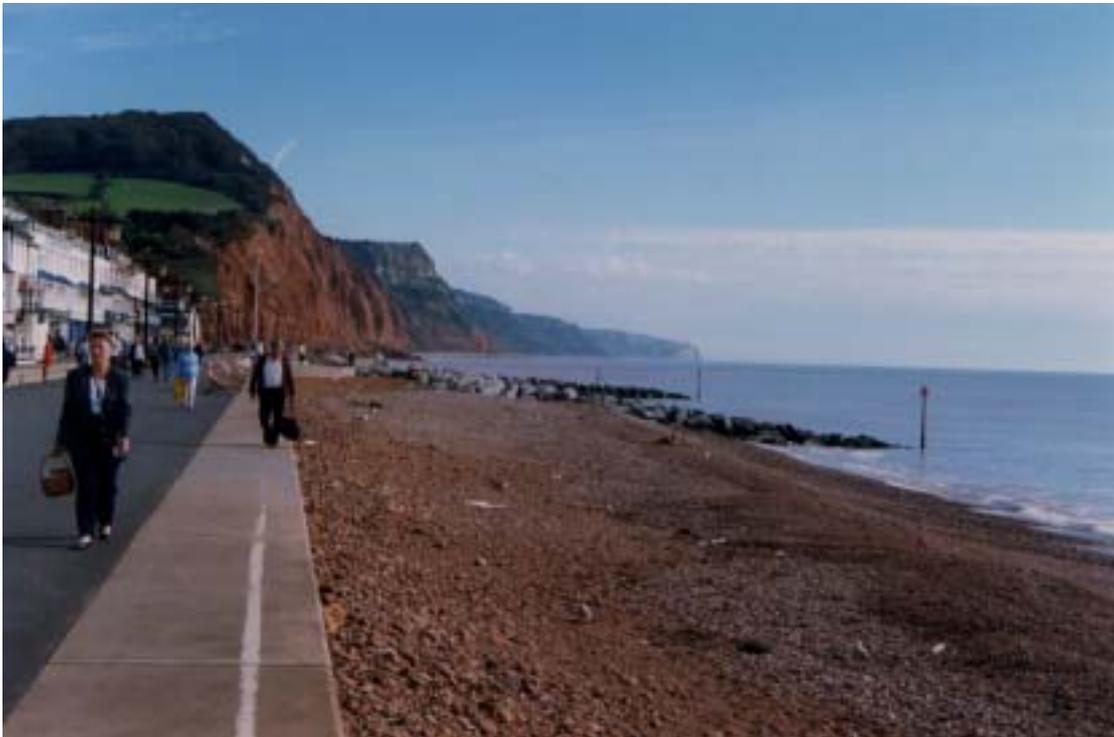
The two photographs show the western and eastern ends of the nourished frontage. The improvement in beach width has not only effectively reduced the former problems of beach lowering but has also provided a more attractive beach. In addition, the offset breakwaters are also not visually intrusive, being below the horizon at promenade level.

**Rock groynes and beach recharge, eastern end of promenade, Sidmouth**

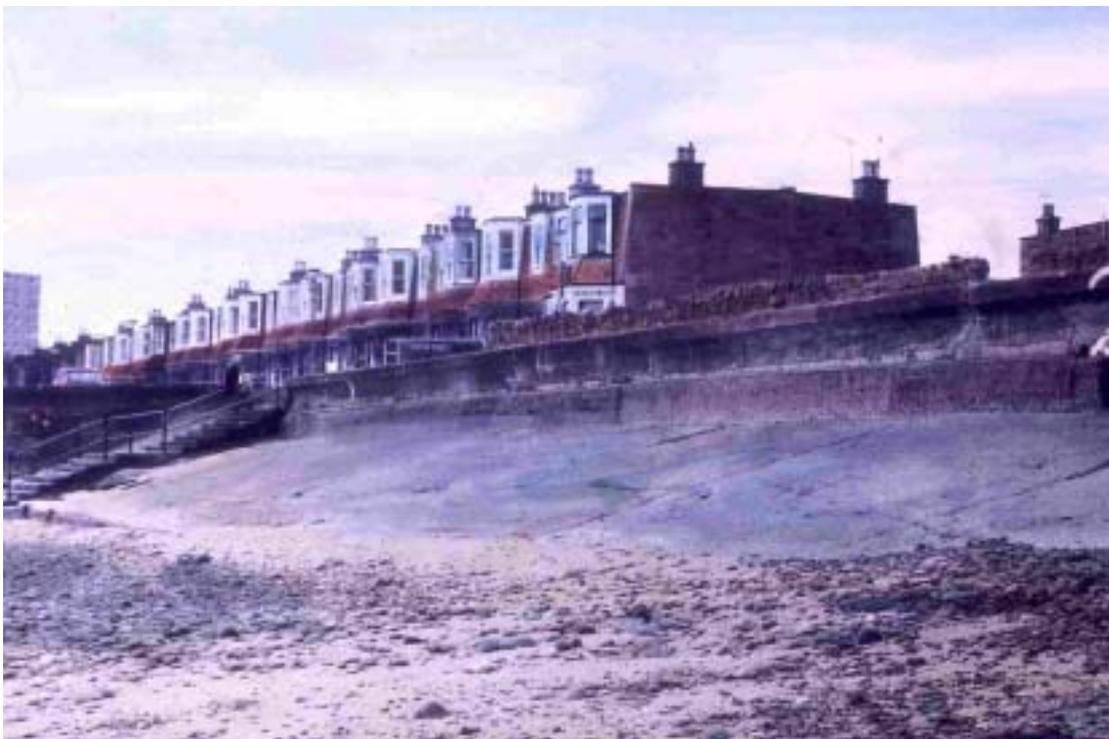
In the United Kingdom, the justification for many beach nourishment schemes has been that the cost of nourishment is considerably less than the cost of reinstatement of existing hard defences. One of the first schemes to be justified on this basis was carried out at Portobello Beach, Edinburgh. This beach is situated on the western side of Edinburgh and faces directly into the mouth of the Firth of Forth. It became denuded as a result of sand abstraction for the glass industry, which began in the 19<sup>th</sup> century and continued up to the 1930's. The promenade seawall at Portobello dates back to 1860. By the late 1950s, the lowered beach meant that the wall was under continuous wave attack, with resulting frequent serious overtopping (see plate below). By this time the beach had flattened and the median sand grain size was 0.2mm.

**Portobello Beach, Edinburgh (c1970)**

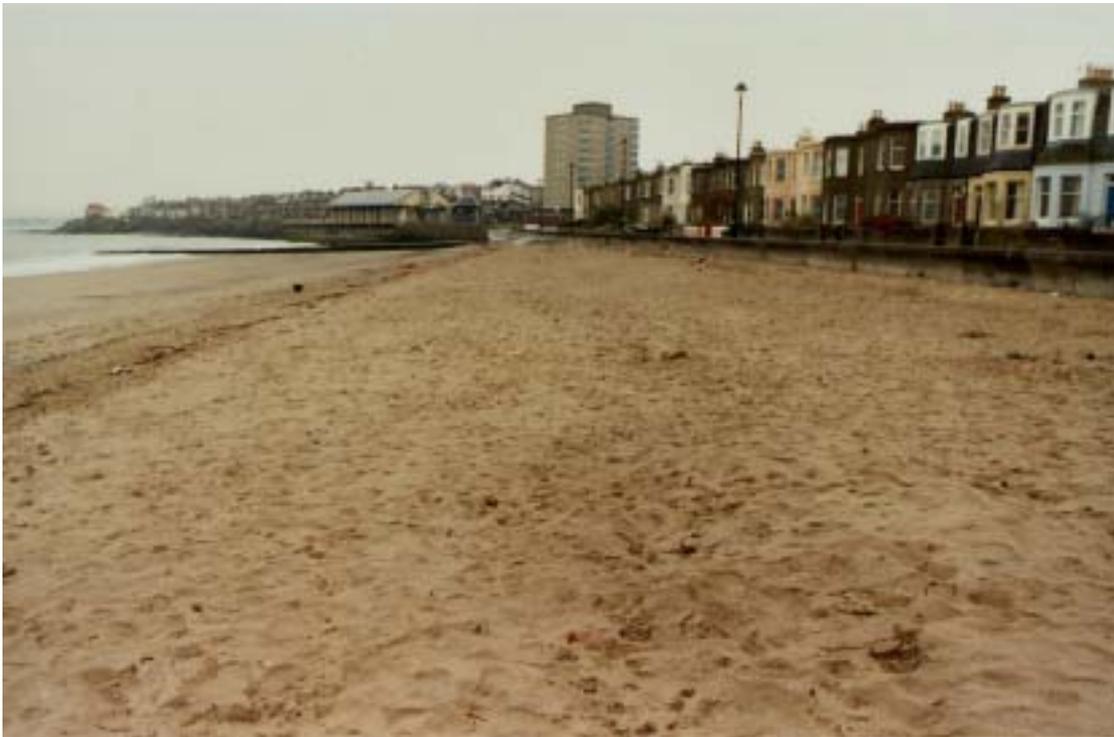
### **Post-nourishment view at Portobello**

nourished beach was held in place by a number of timber groynes, with an (easily adjustable) gabion-type groyne at the eastern (updrift) end of the frontage.
