# Case study 20

## River Ribble floodplain restoration - Yorkshire

This case study relates to information from project SC120015 'How to model and map catchment processes when flood risk management planning'.

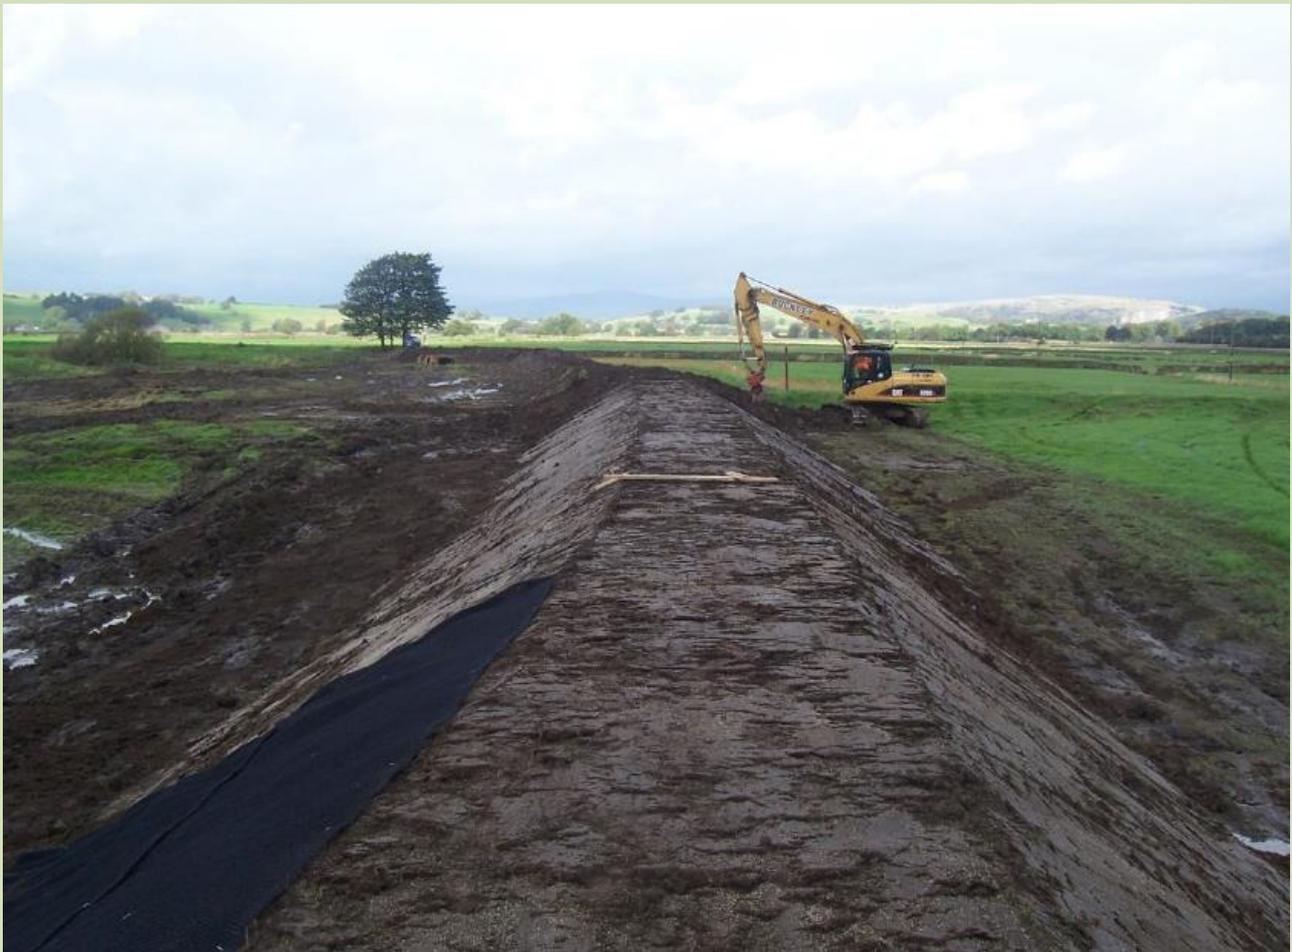
**Figure 2: Set back flood embankment during construction, looking upstream**

Failure of the newly set back flood banks was not modelled. In the event of failure, the flood banks protect agricultural land rather than property (see Figure 2). The long-term monitoring put in place will be useful for assessing the effectiveness of the restoration against the long-term aims set out in Table 1.
